Gerard v. Omega Flex

March 20, 2016

Executive Summary

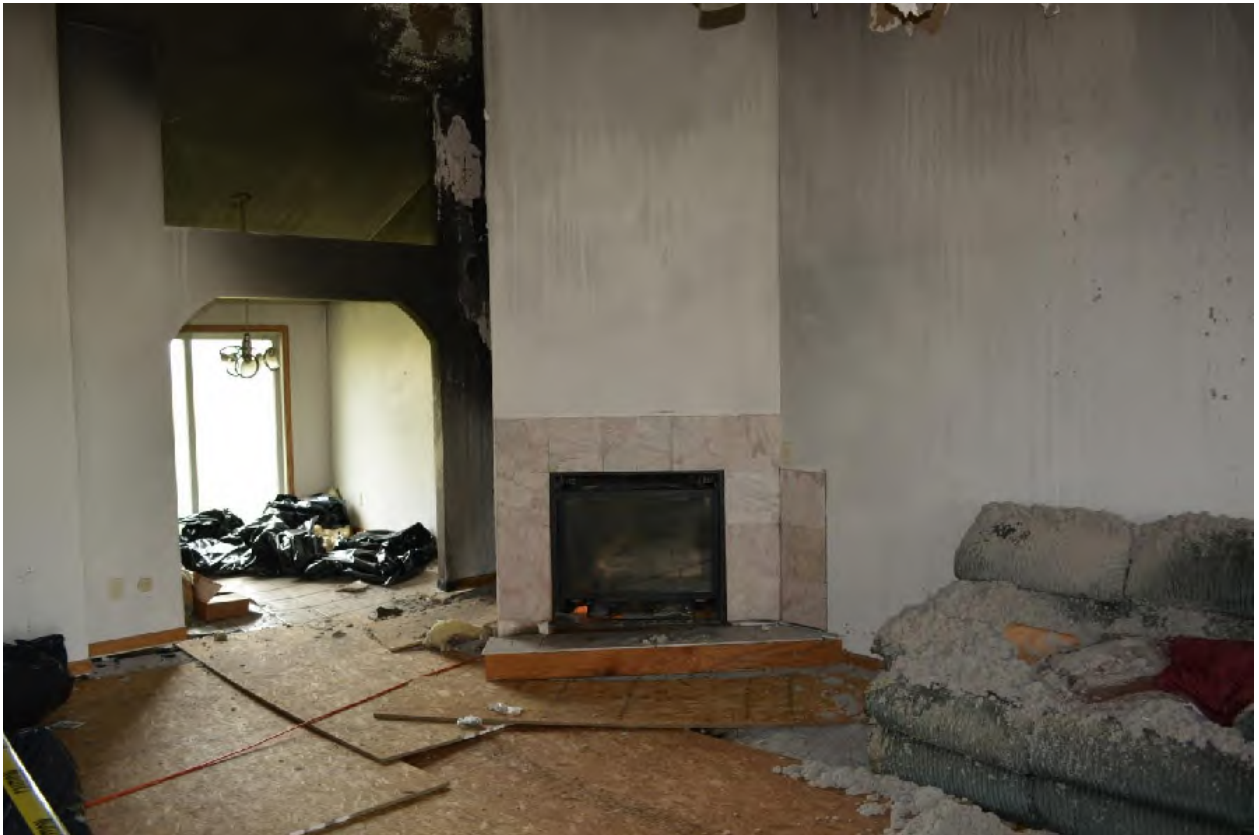
Mr. Gerard observed flames coming from the front of the base of the fireplace just after he heard the lightning strike. There was fire damage to the floor in the vicinity of the fireplace (see Figure 6 and Figure 7) and smoke damage throughout the first floor.

Figure 6. Photograph of the living room fireplace. There was fire damage to the floor in front of the fireplace, covered by oriented strand boards in the photograph.

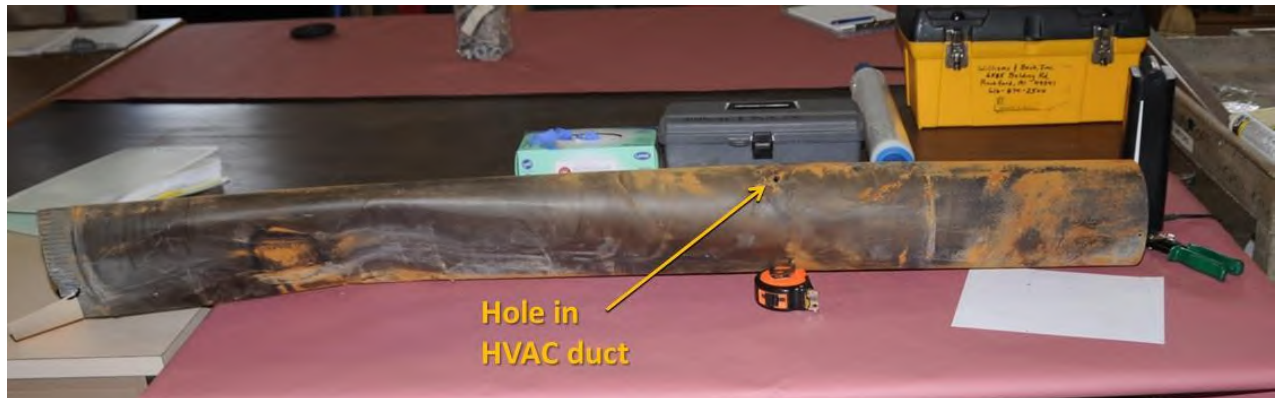
Figure 11. Photograph of the south section of the HVAC duct.

A hole was found in the south section of the HVAC duct. The location of the hole is shown above in Figure 8 and Figure 11. The hole had molten and resolidified metal around the edge (see Figure 13), indicating that it was caused by electrical arcing.

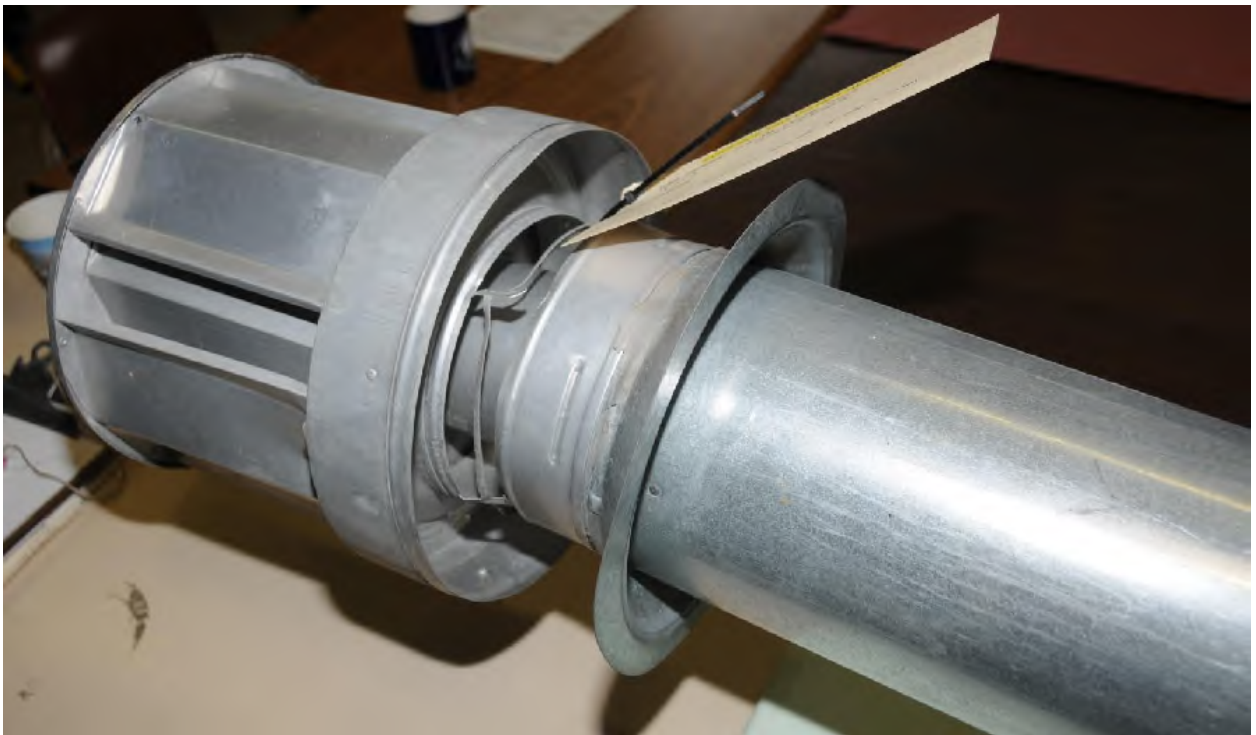
The flue pipe for the fireplace comprised multiple sections of double-walled vent piping (see Figure 14). It terminated at the top with a chimney cap (see Figure 15). There were multiple locations on the chimney cap where the metal had melted and resolidified (see Figure 16 and Figure 17). This damage indicates that lightning directly struck the flue pipe chimney cap.

Figure 15. Photograph of the chimney cap at the top of the fireplace flue piping.

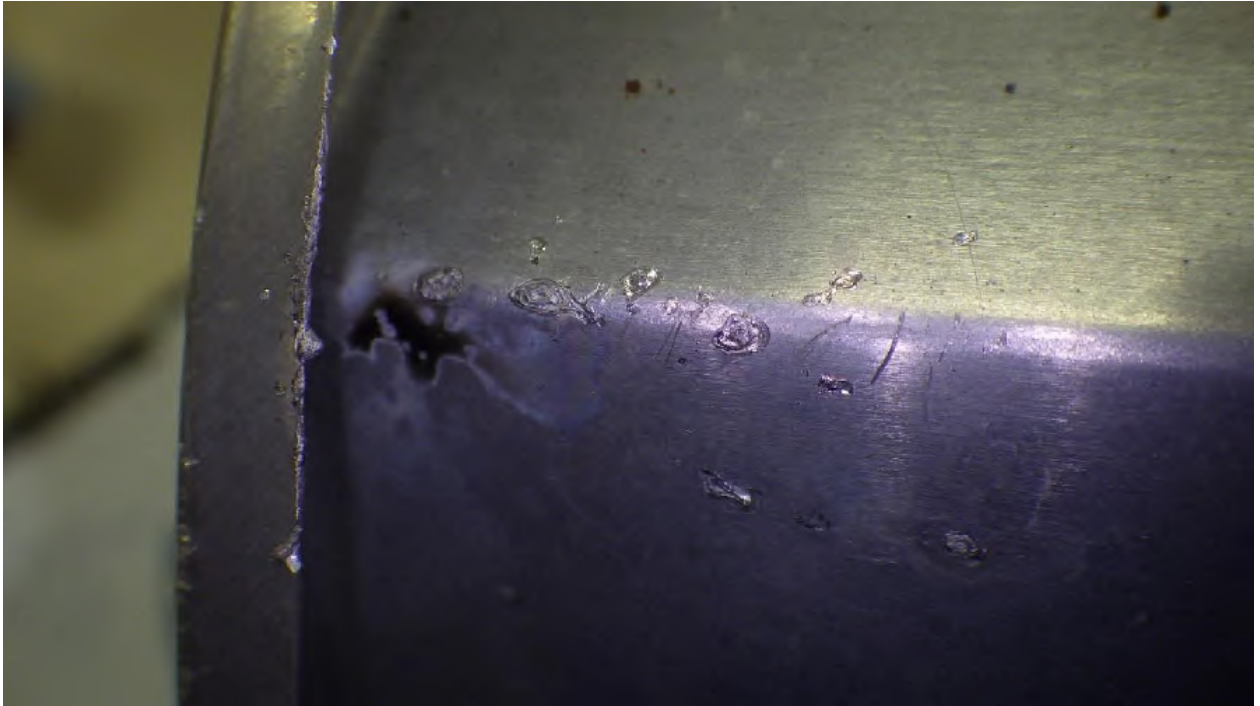
Figure 16. Example photograph of the electrical damage to the chimney cap.

Mr. Hooker stated that he saw no evidence that the building was directly struck by lightning,¹⁶ and further that there was no damage to the chimney cap that is consistent with lightning.¹⁷ Mr. Hooker is incorrect. There were multiple locations on the chimney cap with molten and resolidified metal, as well as electrical damage at the seam between adjacent sections of the flue pipe. The damage to the chimney cap could only have been caused by electrical arcing, and there were no sources of electrical energy on the roof of the Gerard home that could have caused the damage other than lightning. The physical evidence unambiguously shows that the chimney cap was struck by lightning. Mr. Hooker has provided no alternative explanation of the damage.

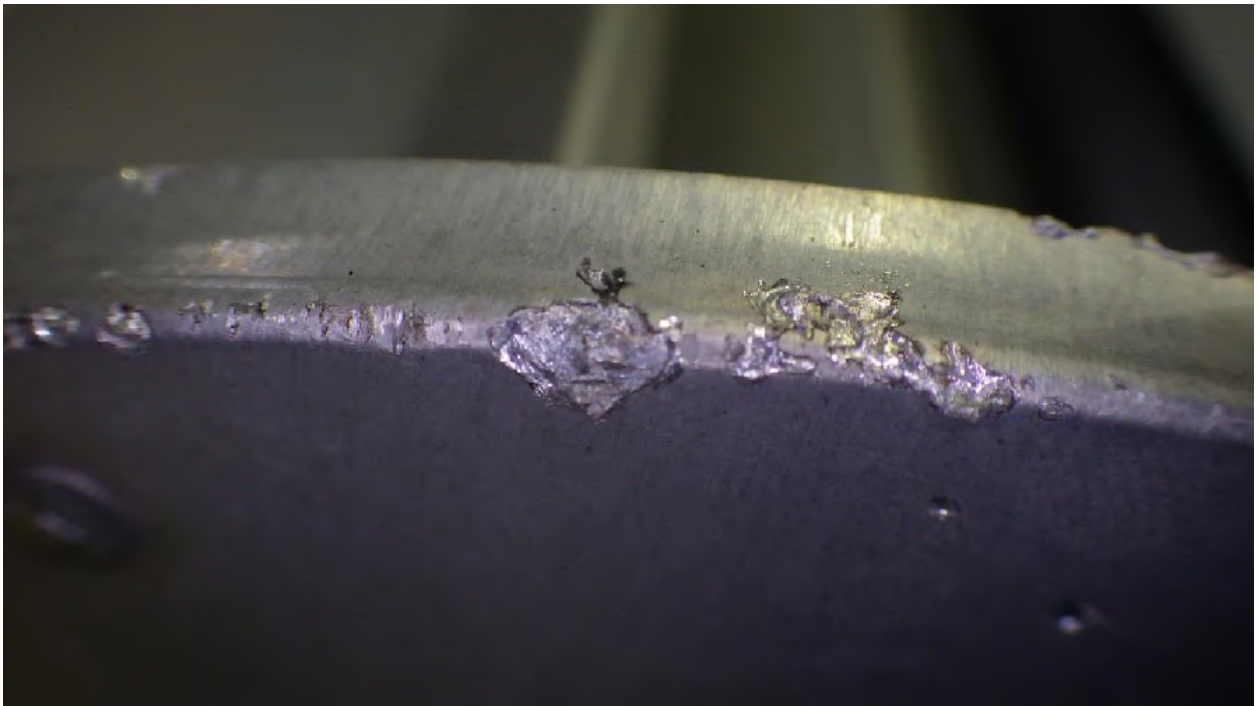
Figure 17. Example photograph of the electrical damage to the chimney cap.

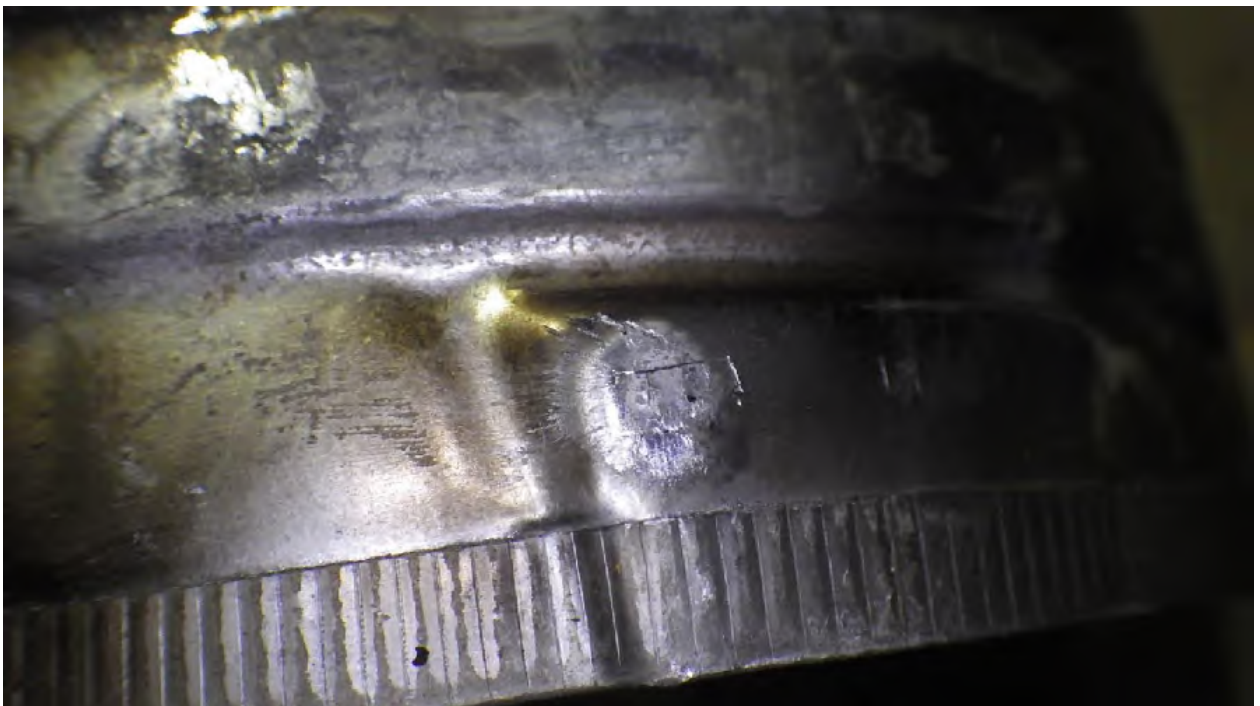
In addition to the electrical damage to the chimney cap, there was also electrical damage at the junction between adjacent sections of the flue piping, as shown in Figure 18 and Figure 19. This electrical damage is an additional indication that the flue piping was directly struck by lightning.

Figure 19. Photograph of electrical damage on the outside of the flue piping at a location where adjacent sections of flue piping overlapped.

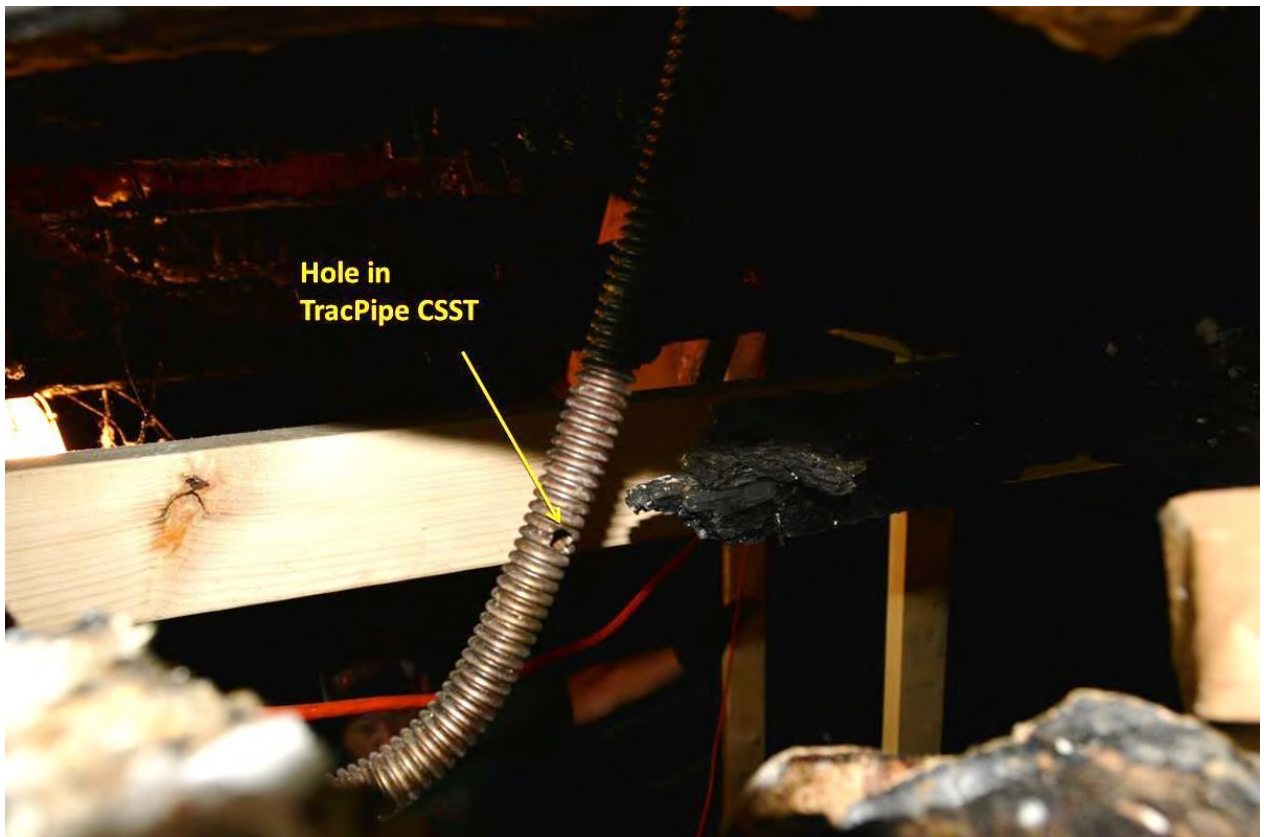
Figure 25. Photograph of the location of the larger hole in the TracPipe CSST.
